CTION OF A 12-YEAR-OLD GLUED-LAMINATED

STRINGER BRIDGE WITH NAILED-LAMINATED DECK--

DECAY HAZARD ASPECTS

Report to Division of Engineering,
Forest Service

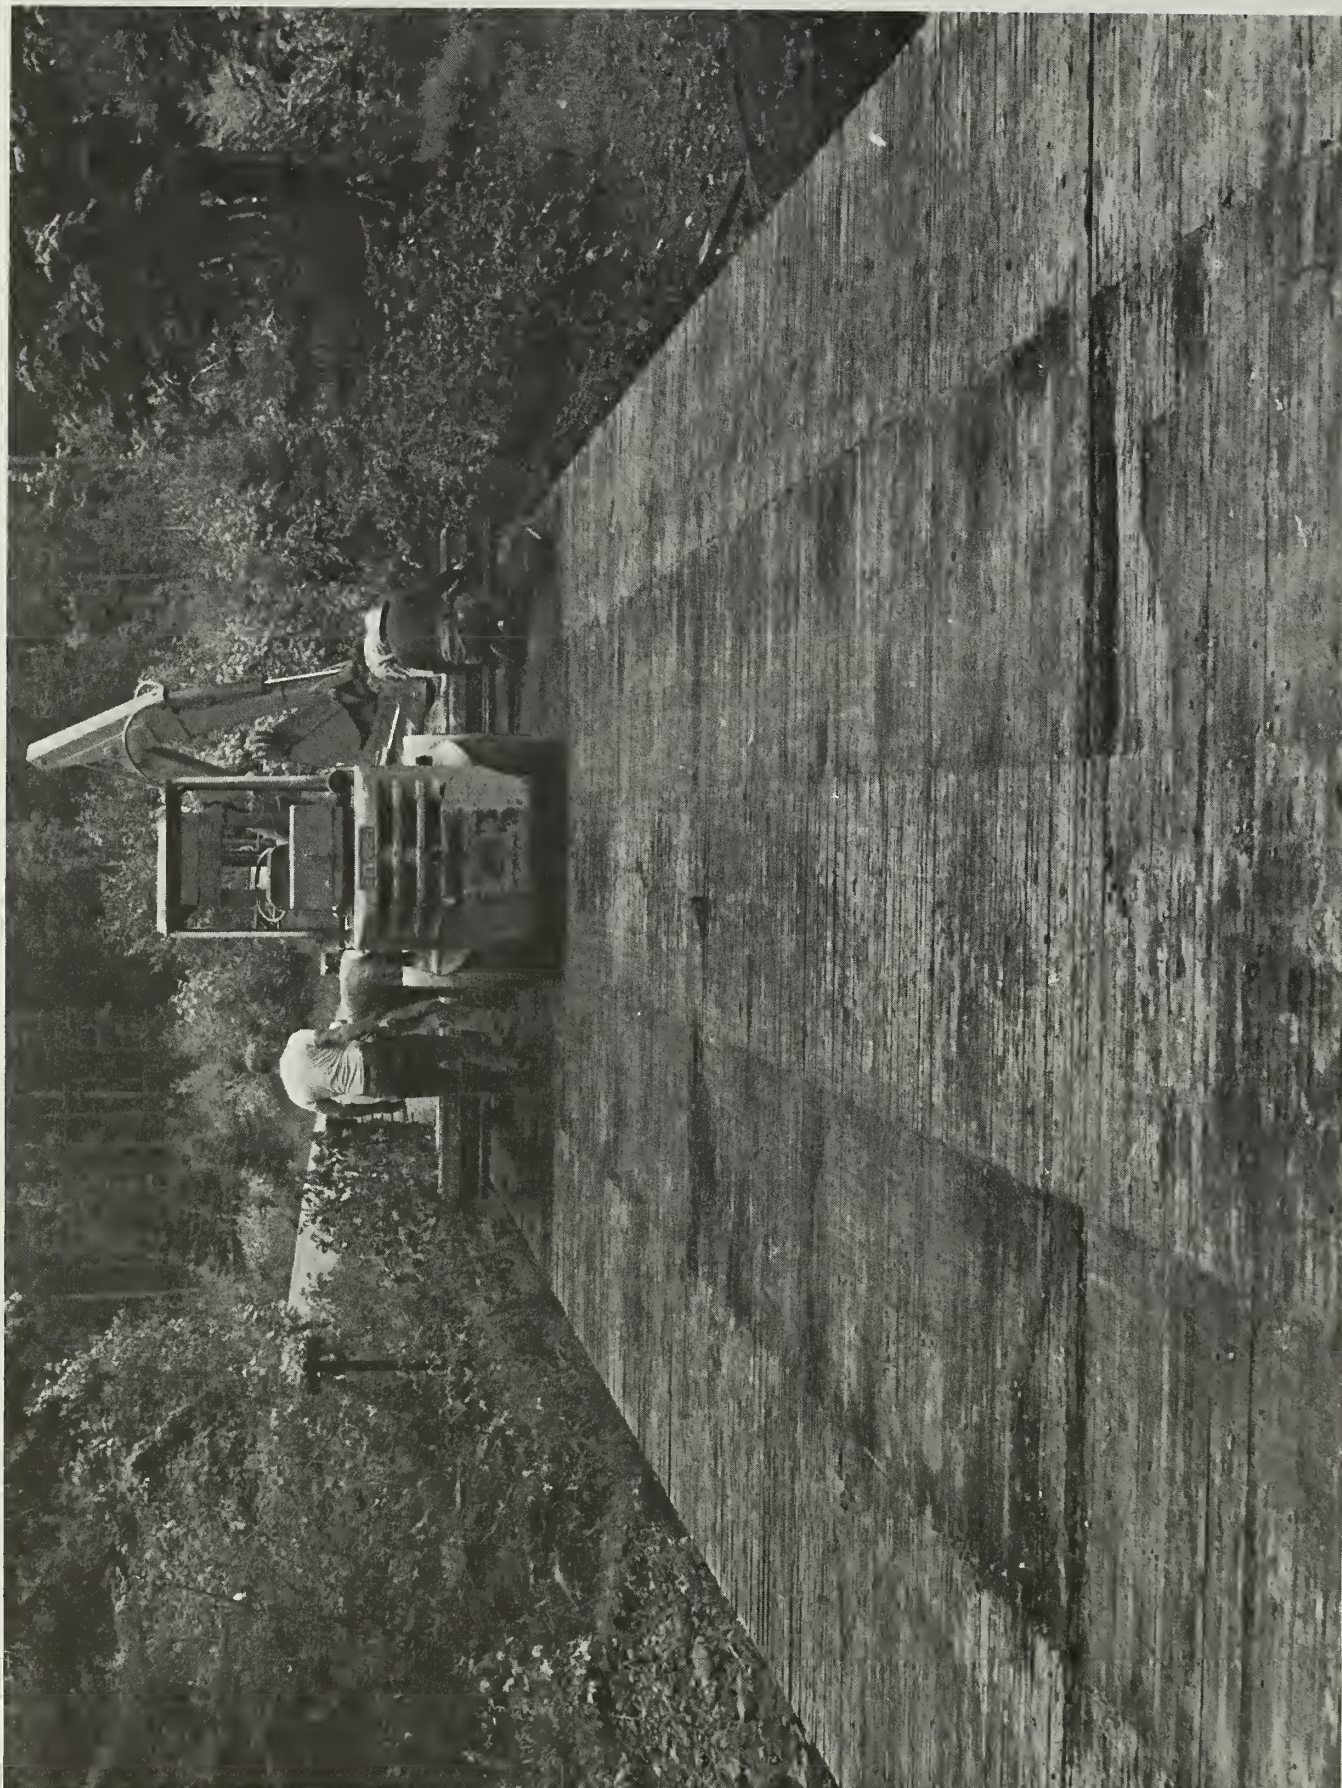
Throughout the history of this bridge, the deck surface has had steel tread plates in the tread areas. At no time has the deck surface been protected by any other material. The common difficulty experienced with tread plates was in evidence on the Panther Creek Bridge. Some bolts which hold the tread plates in place were sheared away by snowplows so that the ends and sides of some plates were loose. Where the deck plate ends were loosened and bent downward, gouging and mechanical wear into the decking were noted (fig. 1). The gouging exposed untreated wood in some instances.

Figure 1.--Panther Creek Bridge decking after the removal of the tread plates. Tread-plate areas on the decking are evident from the imprinted pattern in the deck surface and particularly at the ends of loosened tread plates where the abrasion and gouging of the deck boards exposed the untreated wood.

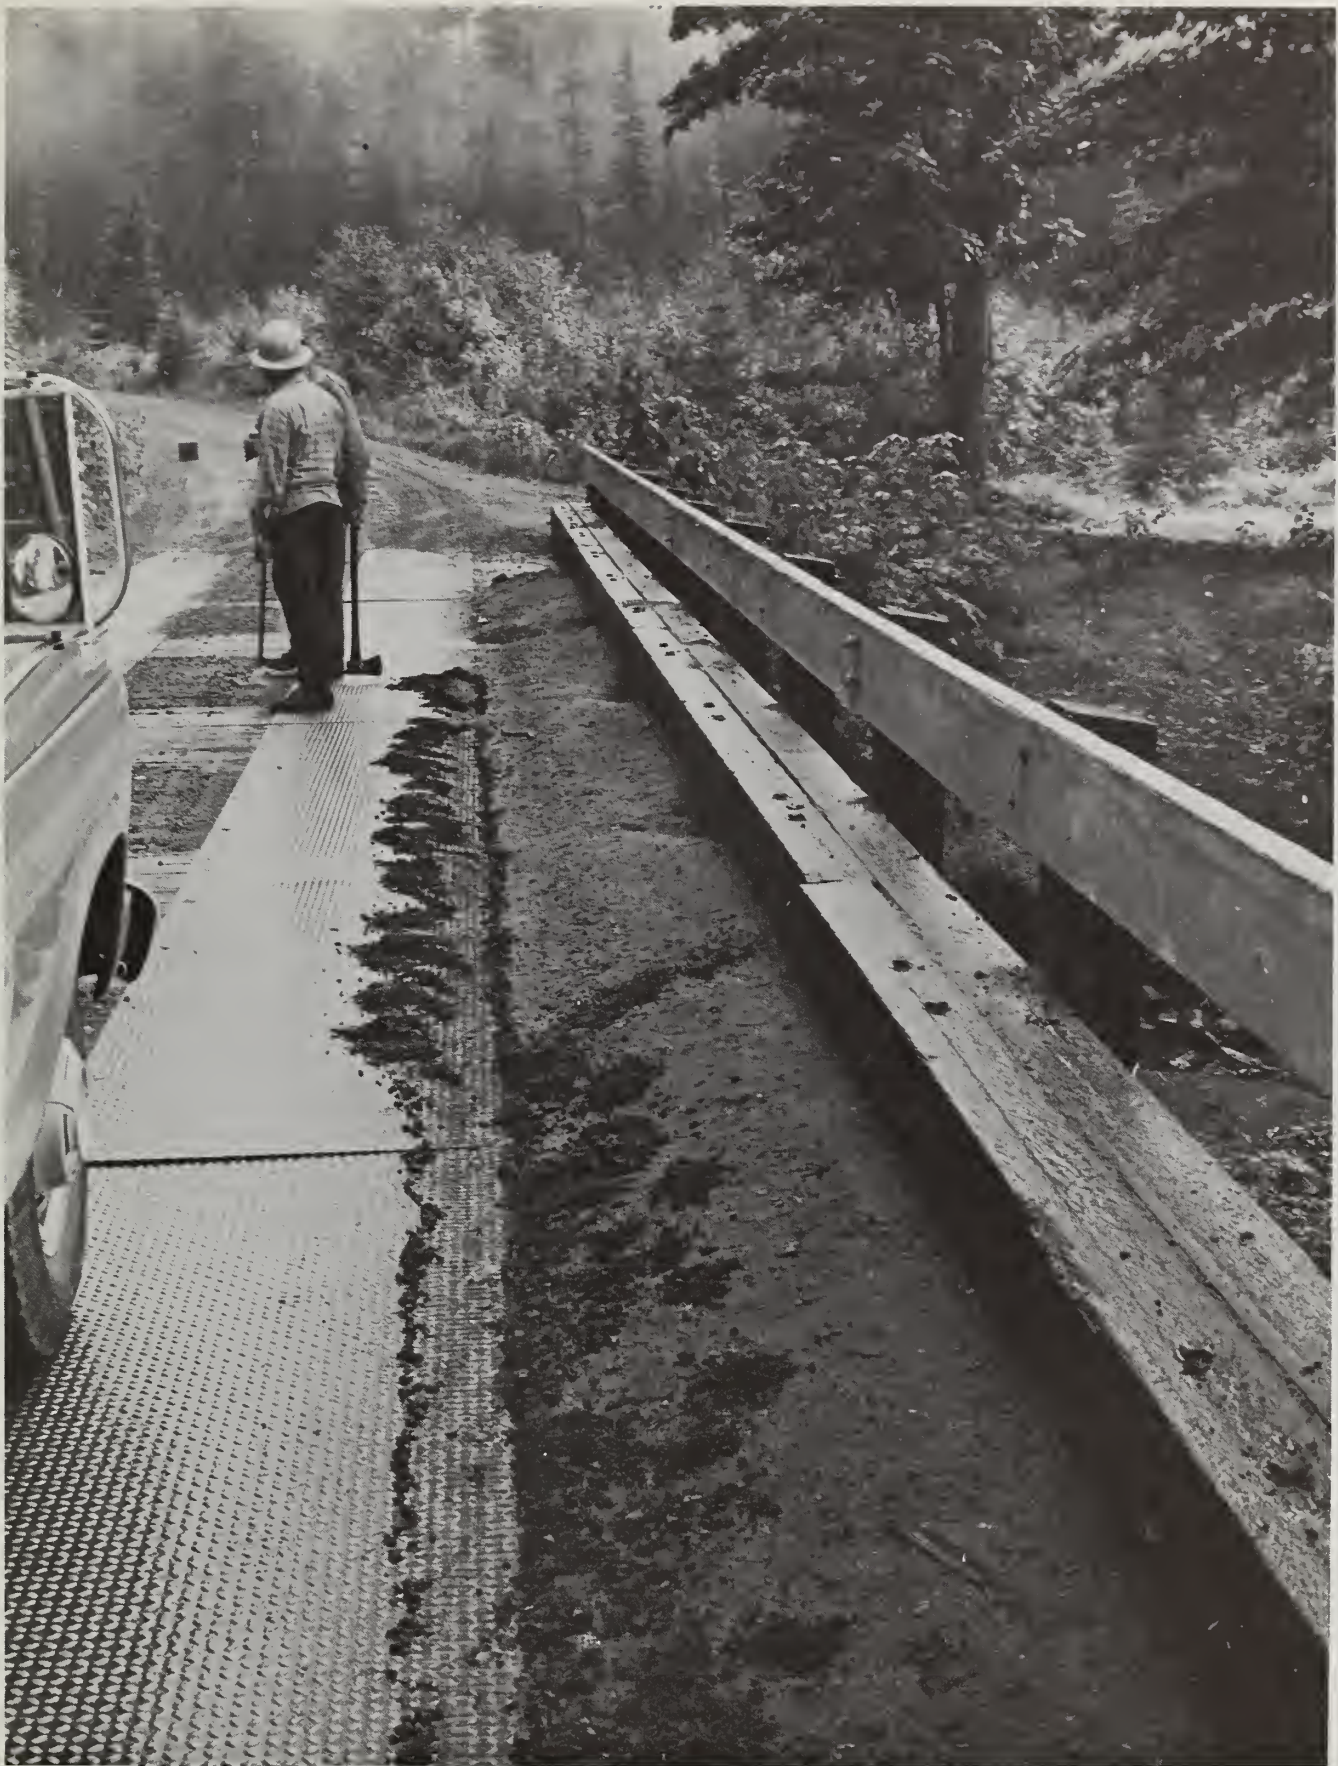
Maintenance had been neglected on the Panther Creek Bridge as was the case to some degree on many Forest Service bridges inspected in the earlier survey. In addition to the poorly attached tread plates, heavy accumulations of gravel, sand, or dirt had built up on the bridge to depths up to 8 to 10 inches, which in some cases blocked adequate lateral deck drainage under the wheel guards (fig. 2). Such heavy accumulations of soil definitely contribute to the hazardously wet conditions that prevail in the decking and in the upper stringer laminates.

Figure 2.--Accumulation of soil on the deck between tread plate and wheel guard. The soil holds water on the deck surface and, at the depth shown, blocks lateral water drainage from the deck surface. Although such accumulations may be present only during the summer and fall, the resulting increase in bridge member wetting comes at a period when temperatures are favorable for decay. (M 138 106)

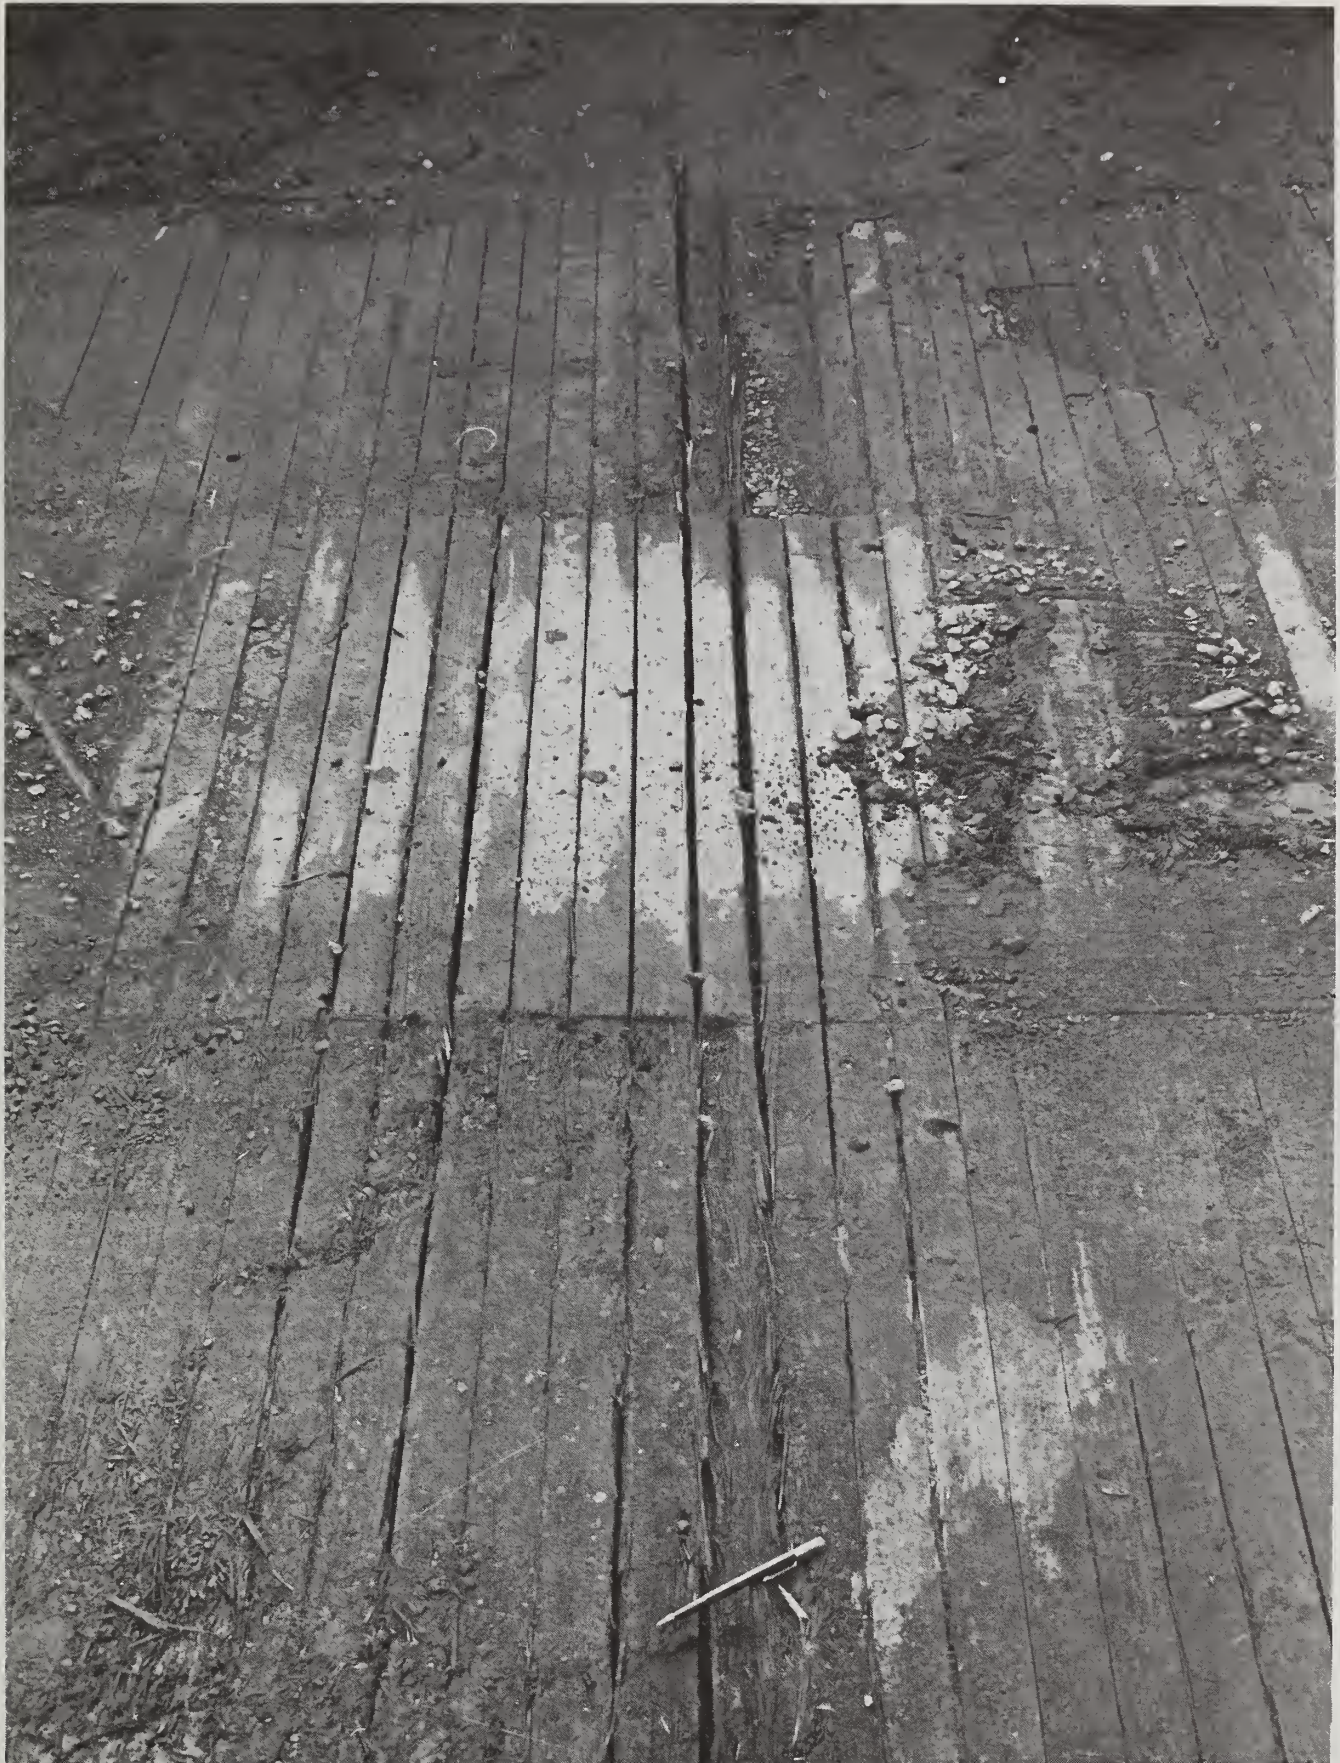
In general, 1/16- to 1/4-inch spaces were found between decking boards and some spaces were as wide as 1/2 inch (fig. 4). These spaces are not entirely attributable to shrinkage since many boards were still at a relatively high moisture content. Part of the spaces result from deck movement and to a somewhat loosely laid original deck. These spaces frequently were partially filled with a mixture of creosote and sandy loam soil. Often such material was firmly compacted and adhering to one or the other of the adjacent pieces of decking (fig. 5), so that even in the wet condition moderate scraping pressure was required to remove it with either a steel spud or a large carpenter's adze (fig. 6). Considering the man-hours required to carefully remove and clean the decking, and the questionable quality of the decking due to incipient decay that may not have been detected and eliminated, it was obvious that reuse of the old decking was not a practical or economical procedure. However, reuse of some of the old decking was a planned part of the experimental redecking project.

Figure 4.--Open spaces between deck boards of the old nailed-laminated deck on the Panther Creek Bridge after removal of the steel tread plates. This juncture of main and approach span stringers represents the worst decking condition observed on this bridge. (M 138 113)

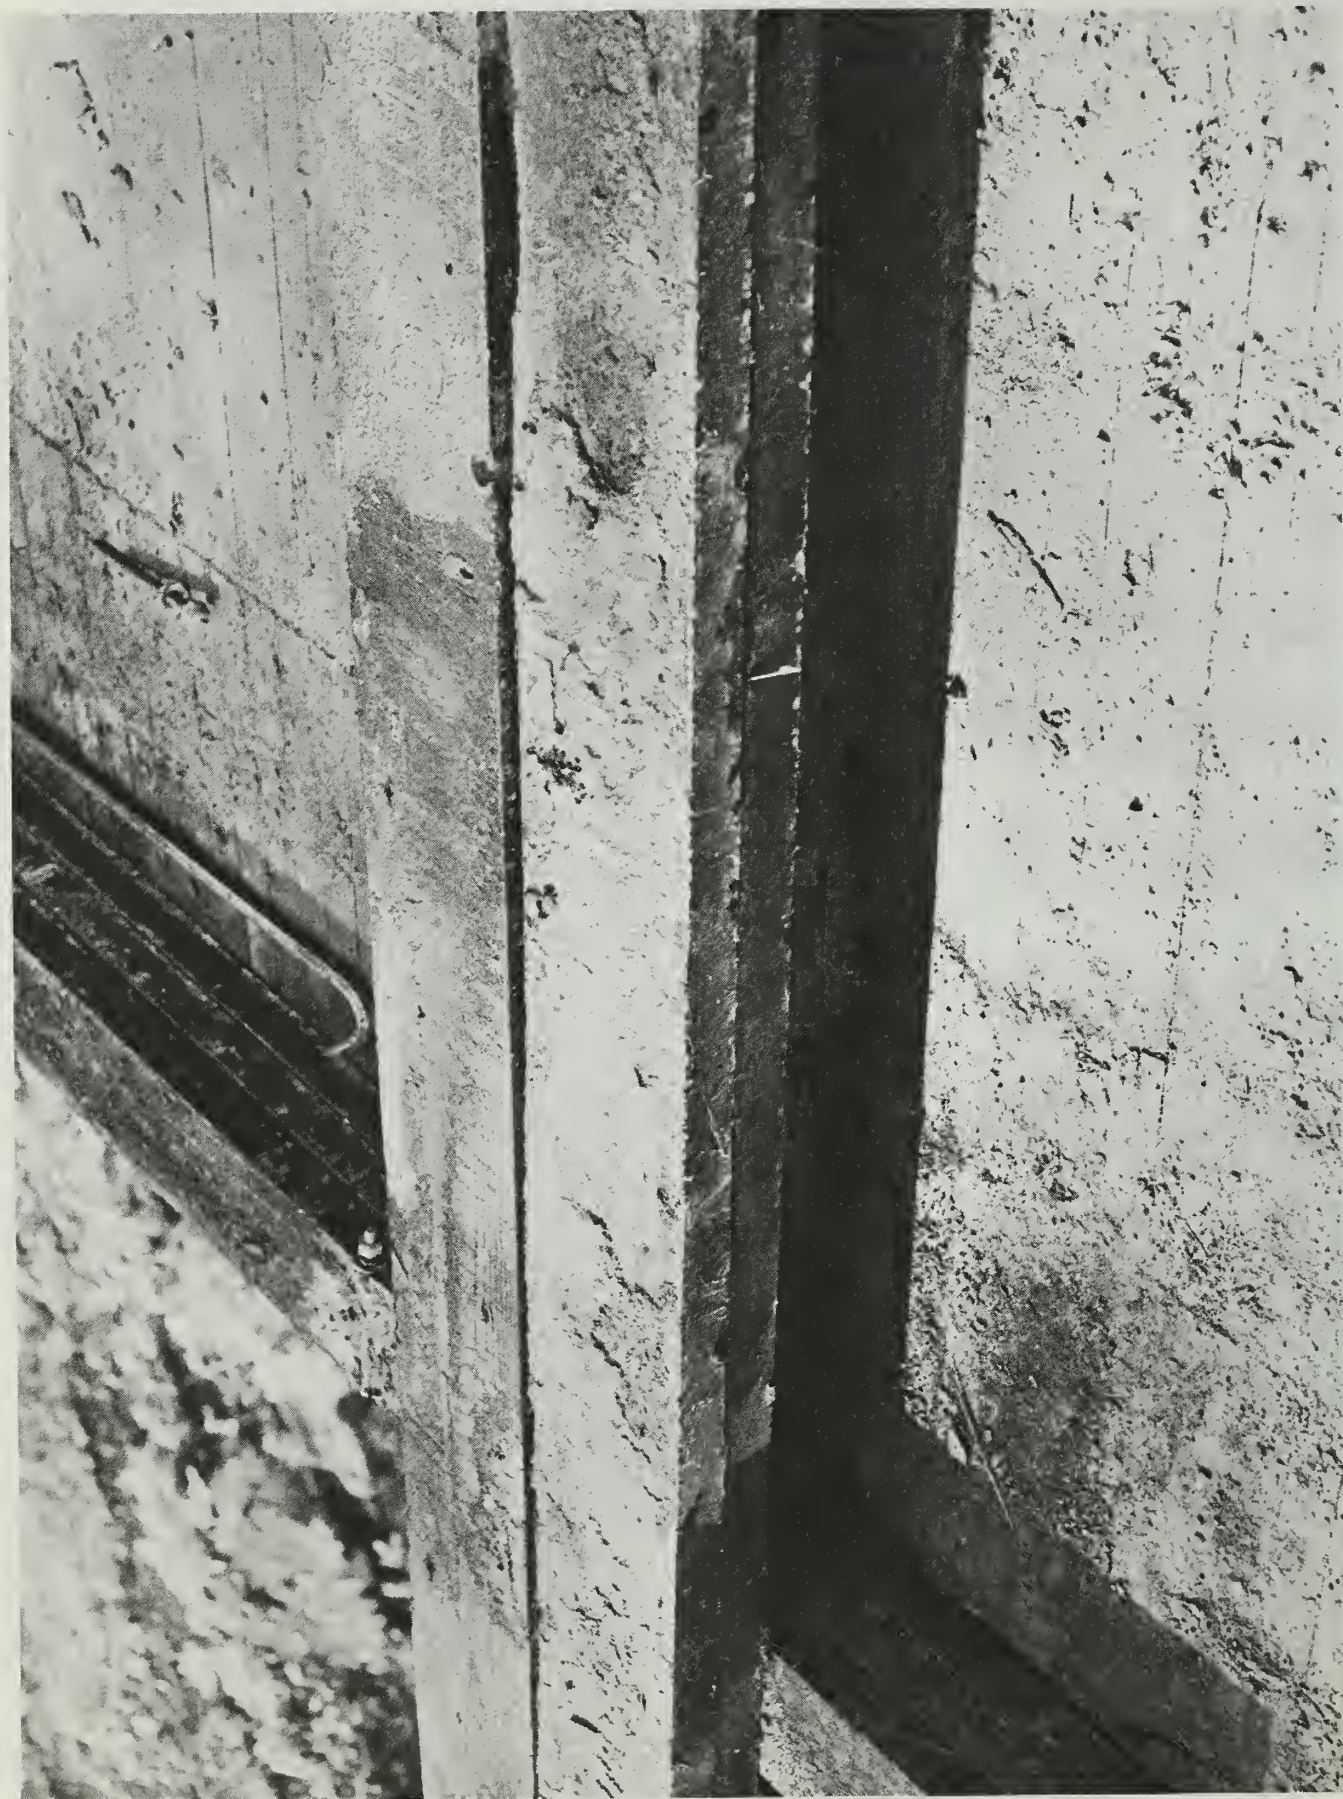
Figure 5.--Many of the decking boards had firmly adhering layers of creosote and sandy loam soil. These accumulations of material between the in-place boards represented open spacing between the boards amounting to as much as 1/2 inch.

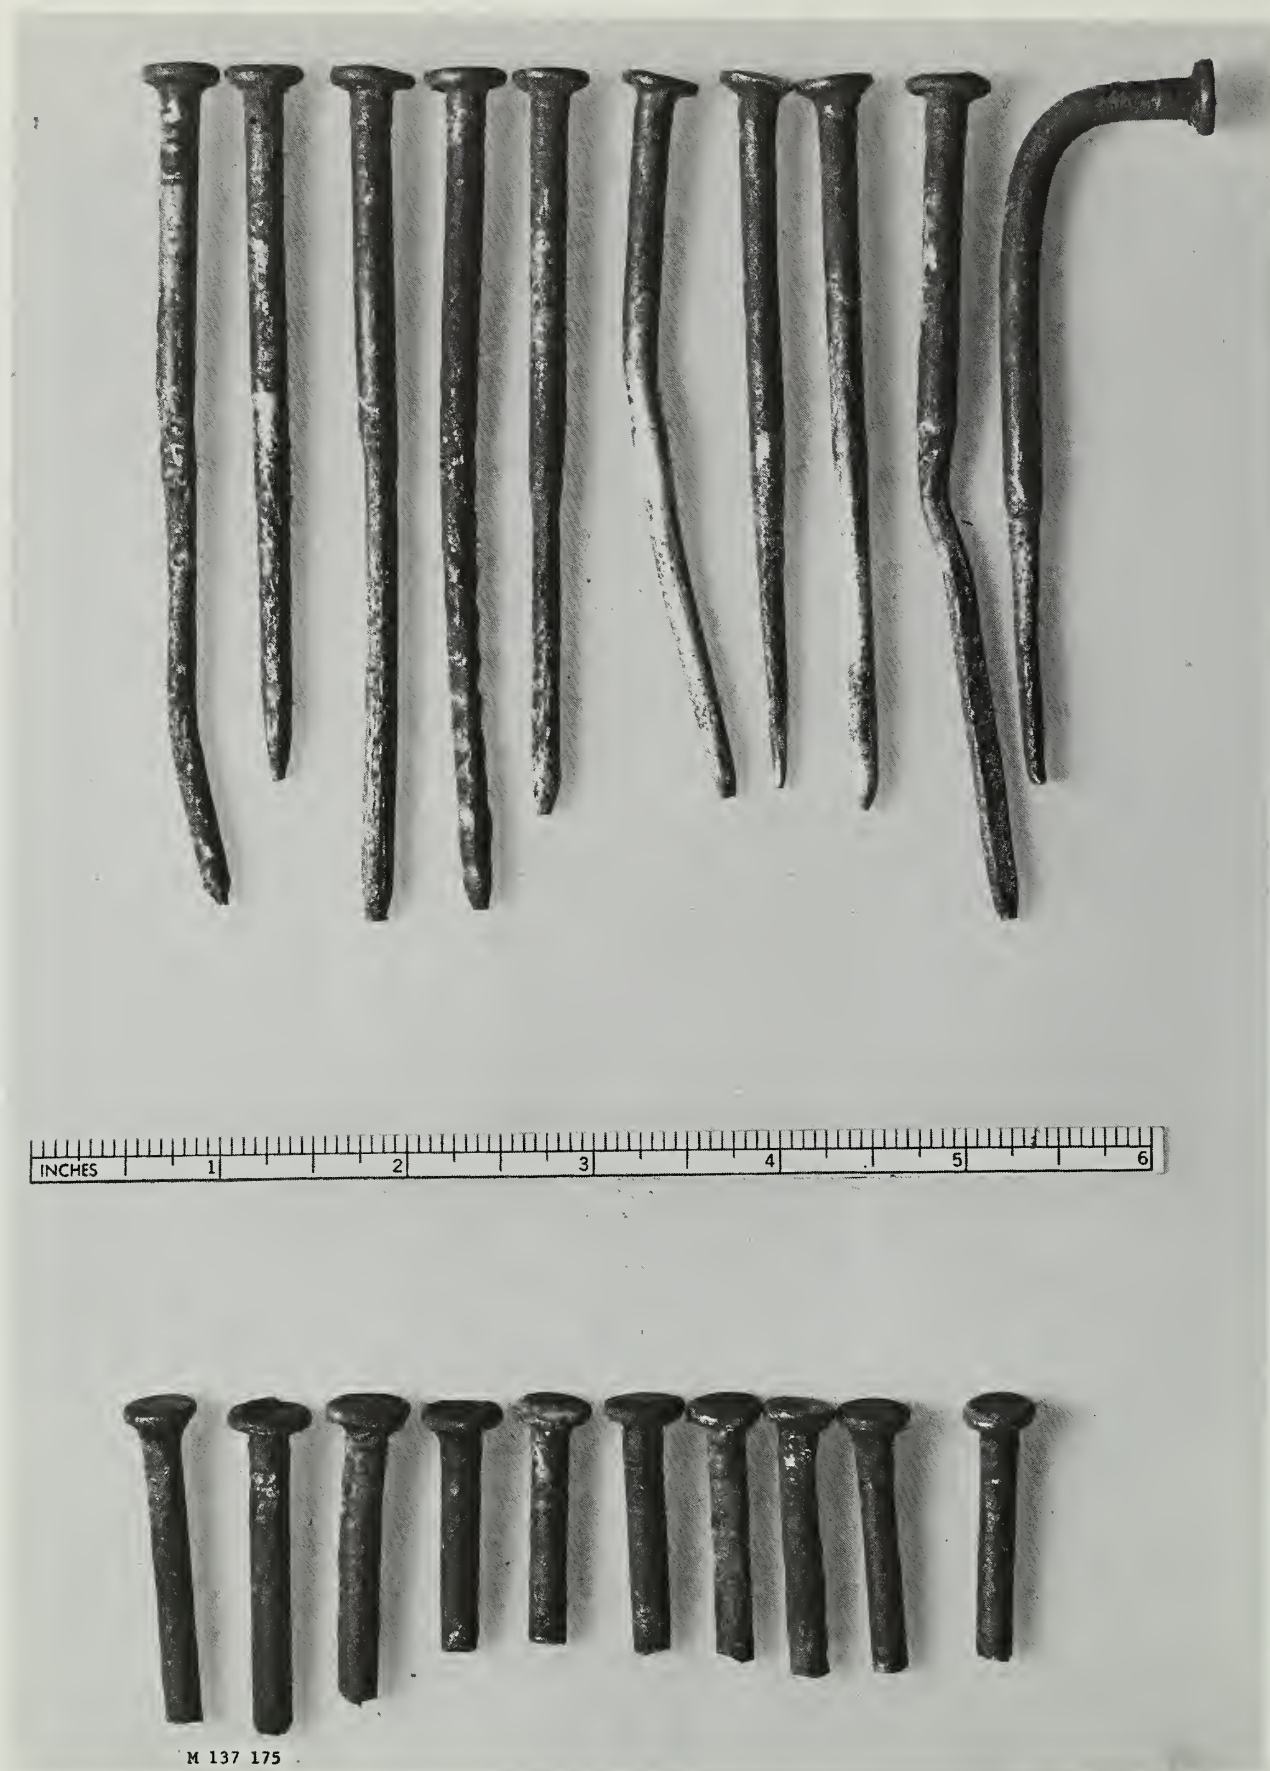
Throughout the deck removal procedure, careful observations were made of all deck fasteners. A collection of broken or deformed nails was made and representative examples are shown in figures 7 and 8. Both the through-nails and the toenails were frequently either bent or broken. In numerous cases, the through-nails were broken in two or three pieces, but the pieces usually remained in the boards into which they had been driven. Nails retaining their full length were often reduced in diameter. In some cases, these nails showed long, tapered reductions which appeared to be the result of abrasive wear, of rust, or a combination of these factors. It was not uncommon to observe all galvanizing eliminated from two-thirds of a nail's length. In other cases, nails appeared to have retained their full diameter but simply had been broken near their midpoints, presumably as a result of repeated flexing.

Figure 7.--Severely deformed or broken nails were commonly encountered throughout the deck removal operation. Many nails showed a reduction in cross-sectional diameter, usually in the form of tapering (top row in figure). Also, a large number of through-nails in the deck planks were broken from flexural fatigue at intervals varying from 1 to 2-1/2 inches (bottom row). (M 137 175)

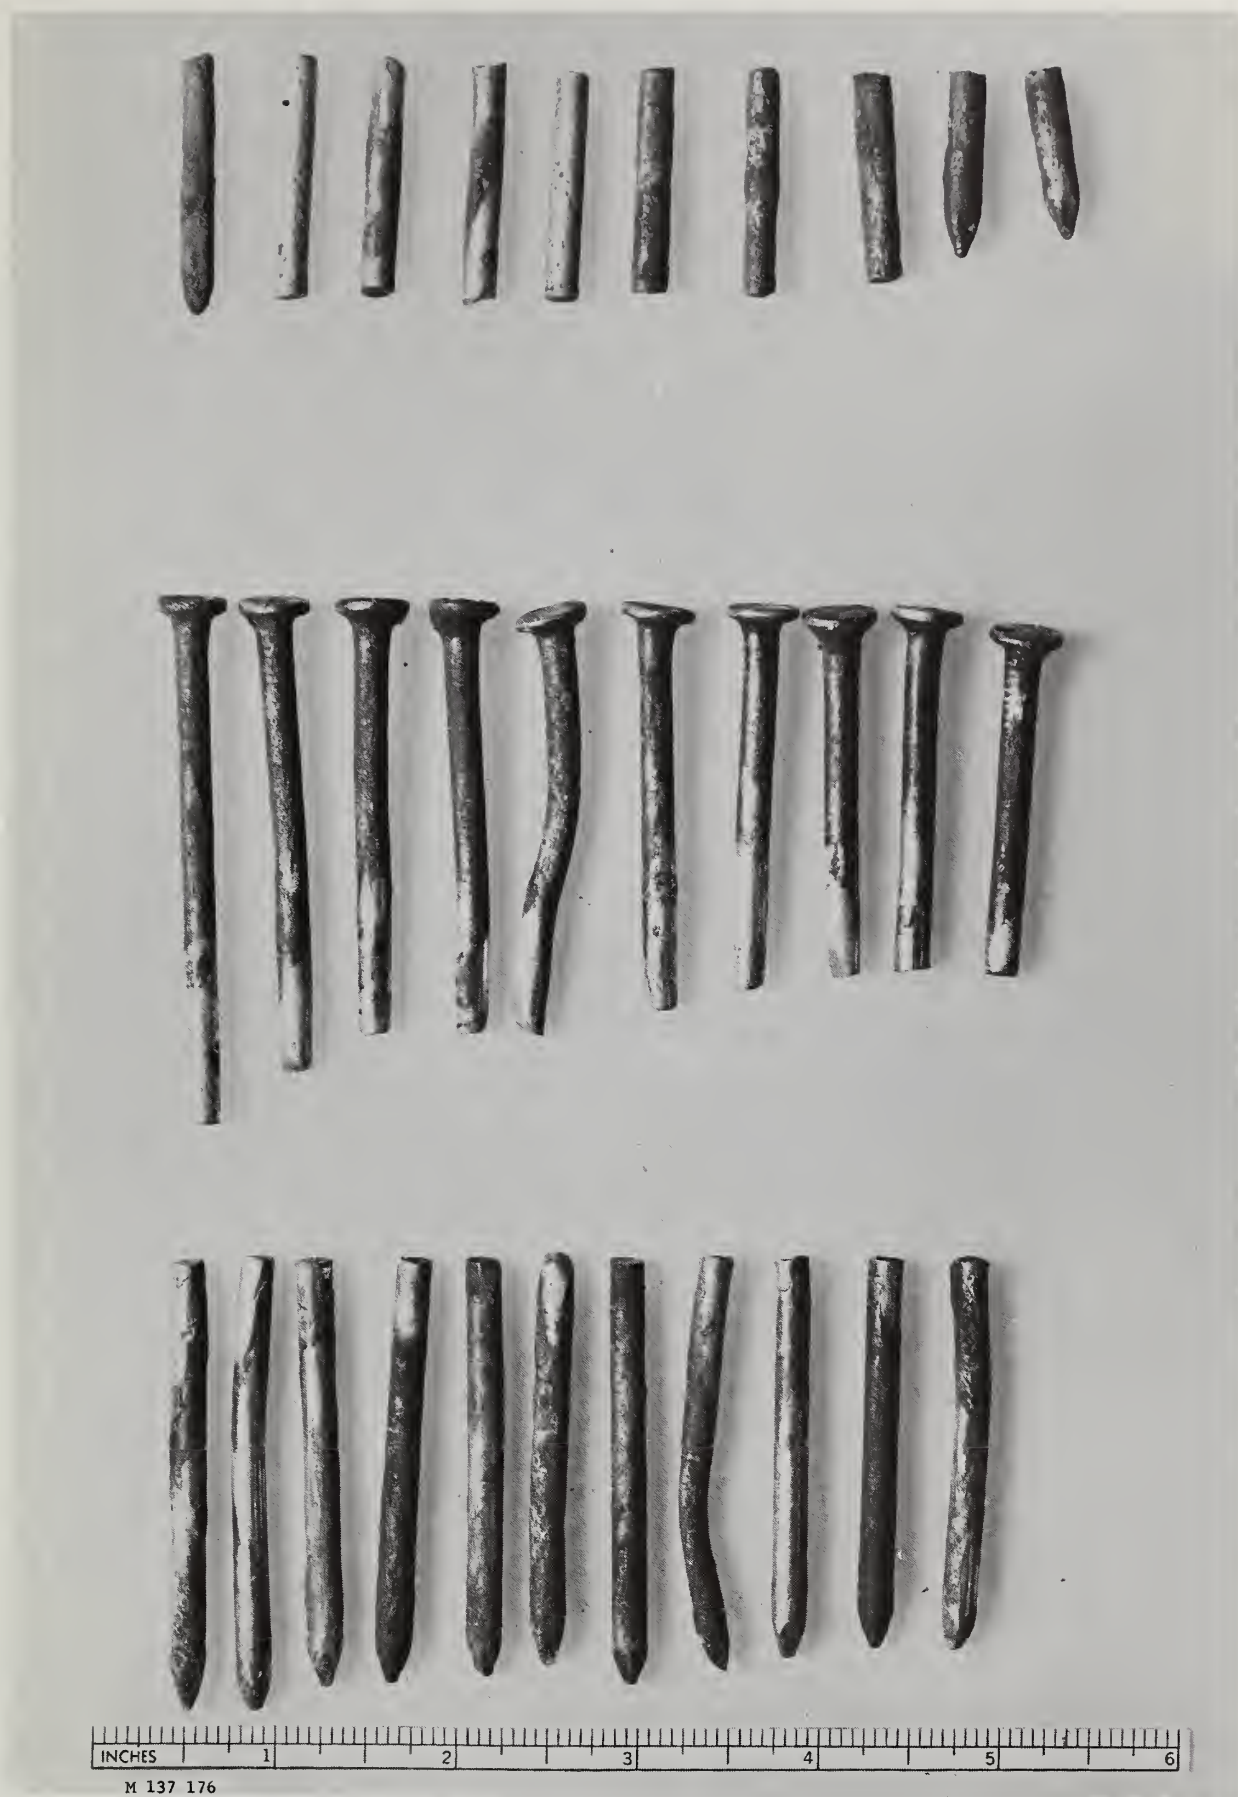
Often the broken ends of such nails were rounded, indicating abrasive action by the sand embedded in the wood as the wood members moved under traffic loading after the nail had broken. In many cases, the nails were rather highly polished, showing no evidence of rust over half of their length. Toenails often showed breaks occurring from a point a half inch below the surface of the stringer up to a point 1/2 inch above the stringer surface. In such cases, the nail end frequently remained firmly implanted in the upper stringer lamination (fig. 9). In other cases, the toenail hole in the top of the stringer was enlarged and the nail had simply moved up and down freely as the deck member moved. Enlargement of the through-nail holes in the decking boards was quite common and in some cases so pronounced that the nails or pieces of nails dropped out of the planks during plank removal.

Figure 8.--Additional Panther Creek Bridge fasteners collected during the deck removal operation. Many of the broken nails had polished and rounded ends, indicating the extent of decking movement and the presence of sandy soil acting as an abrasive. Seven of the nail fragments in the upper row represent center or middle sections of through-nails that were broken into three pieces. (M 137 176)

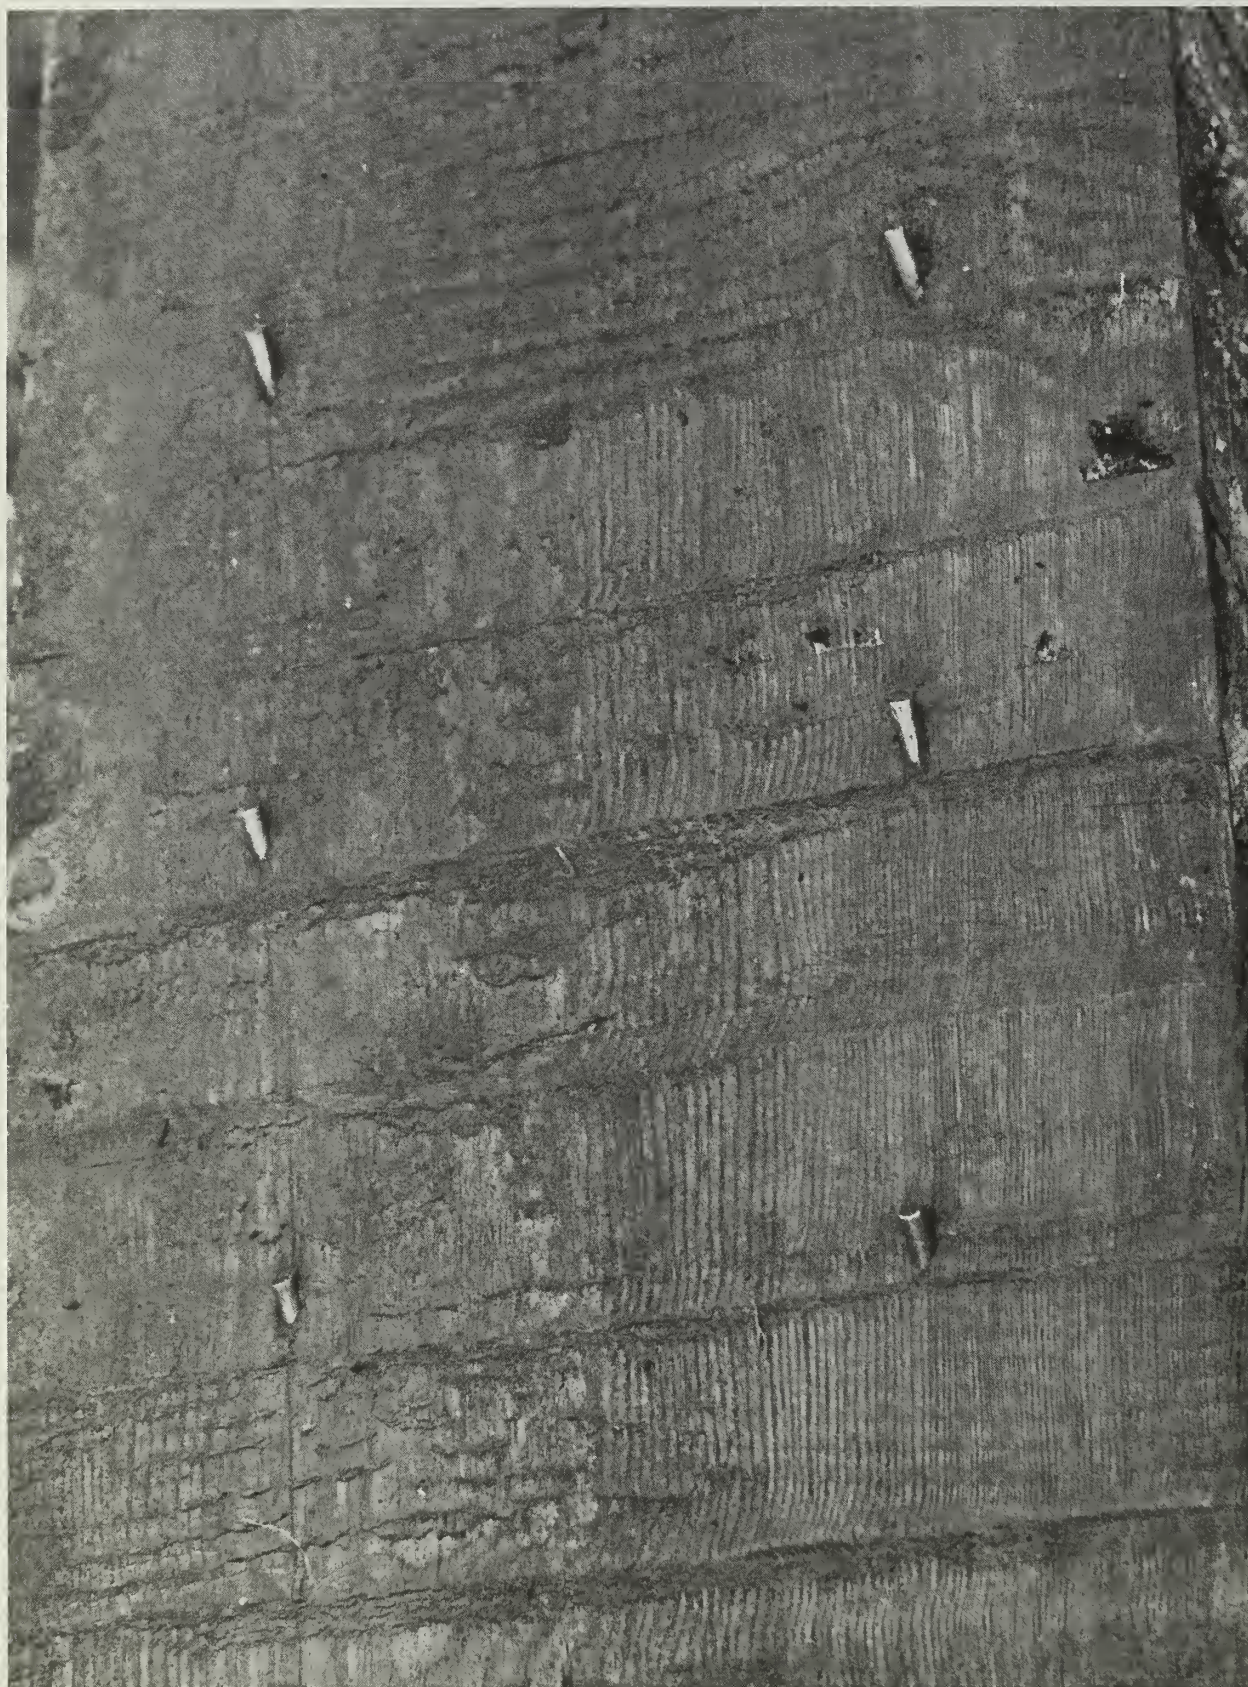
Stringer tops showed corresponding wear, but were characteristically scalloped in a pattern corresponding to the rounded lower edges of the adjacent deck planks (figs. 9 and 13). No accurate measurement of material loss was obtained on the stringer tops, but in some areas most of the preservative-penetrated wood had been removed. This probably represented a loss of surface material from 1/16 to 3/16 inch in depth.

Figure 9.--The upper surface of the center stringer showing broken and polished toenails and the scalloped pattern of wear resulting from pounding of the nominal 2-inch decking against the stringer surface. Practically all of the preservative-impregnated surface wood had been worn away in this area. In an area of broken toenails such as this, the decking obviously was not attached in any substantial degree to the stringer.

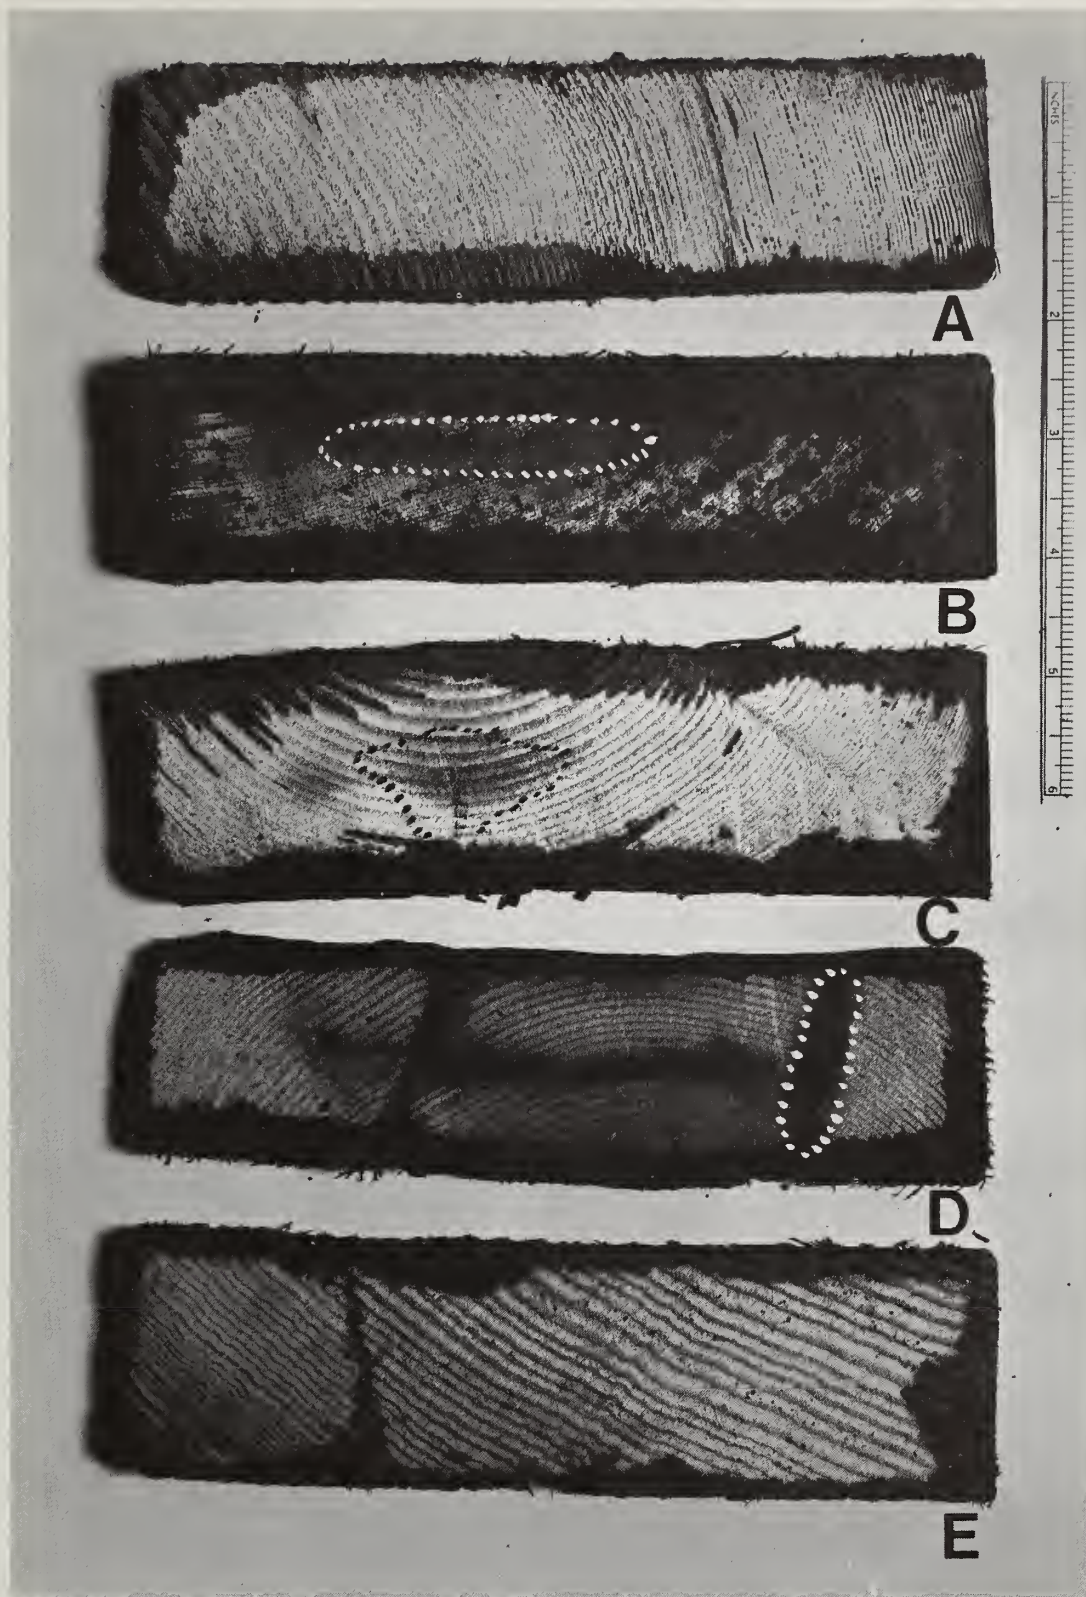
Some of the deck boards not pictured in this report showed greater preservative penetration, and in some cases almost complete penetration where no decay was detected. The problem of decay in preservative-treated decking stems from the fact that a fairly high percentage of the boards, when treated without incising, fail to be adequately penetrated by oilborne preservatives.

Figure 10.--Deck plank samples from the Panther Creek Bridge examined at the Forest Products Laboratory. A, heartwood plank poorly penetrated by the creosote pressure treatment; B, better preservative penetration than shown by most other samples, but typical decay is present in poorly treated interior wood, having gained entry through a hold-down bolt hole several inches from the cross section shown; C, incipient decay with slight iron stain of the interior, untreated wood; D, interior iron-stained wood reflecting the pattern of two through-nails and a tread plate hold-down bolt with typical decay present in alinement with one through-nail area; E, one of few samples with wood splitting associated with through-nailing. (M 137 174)

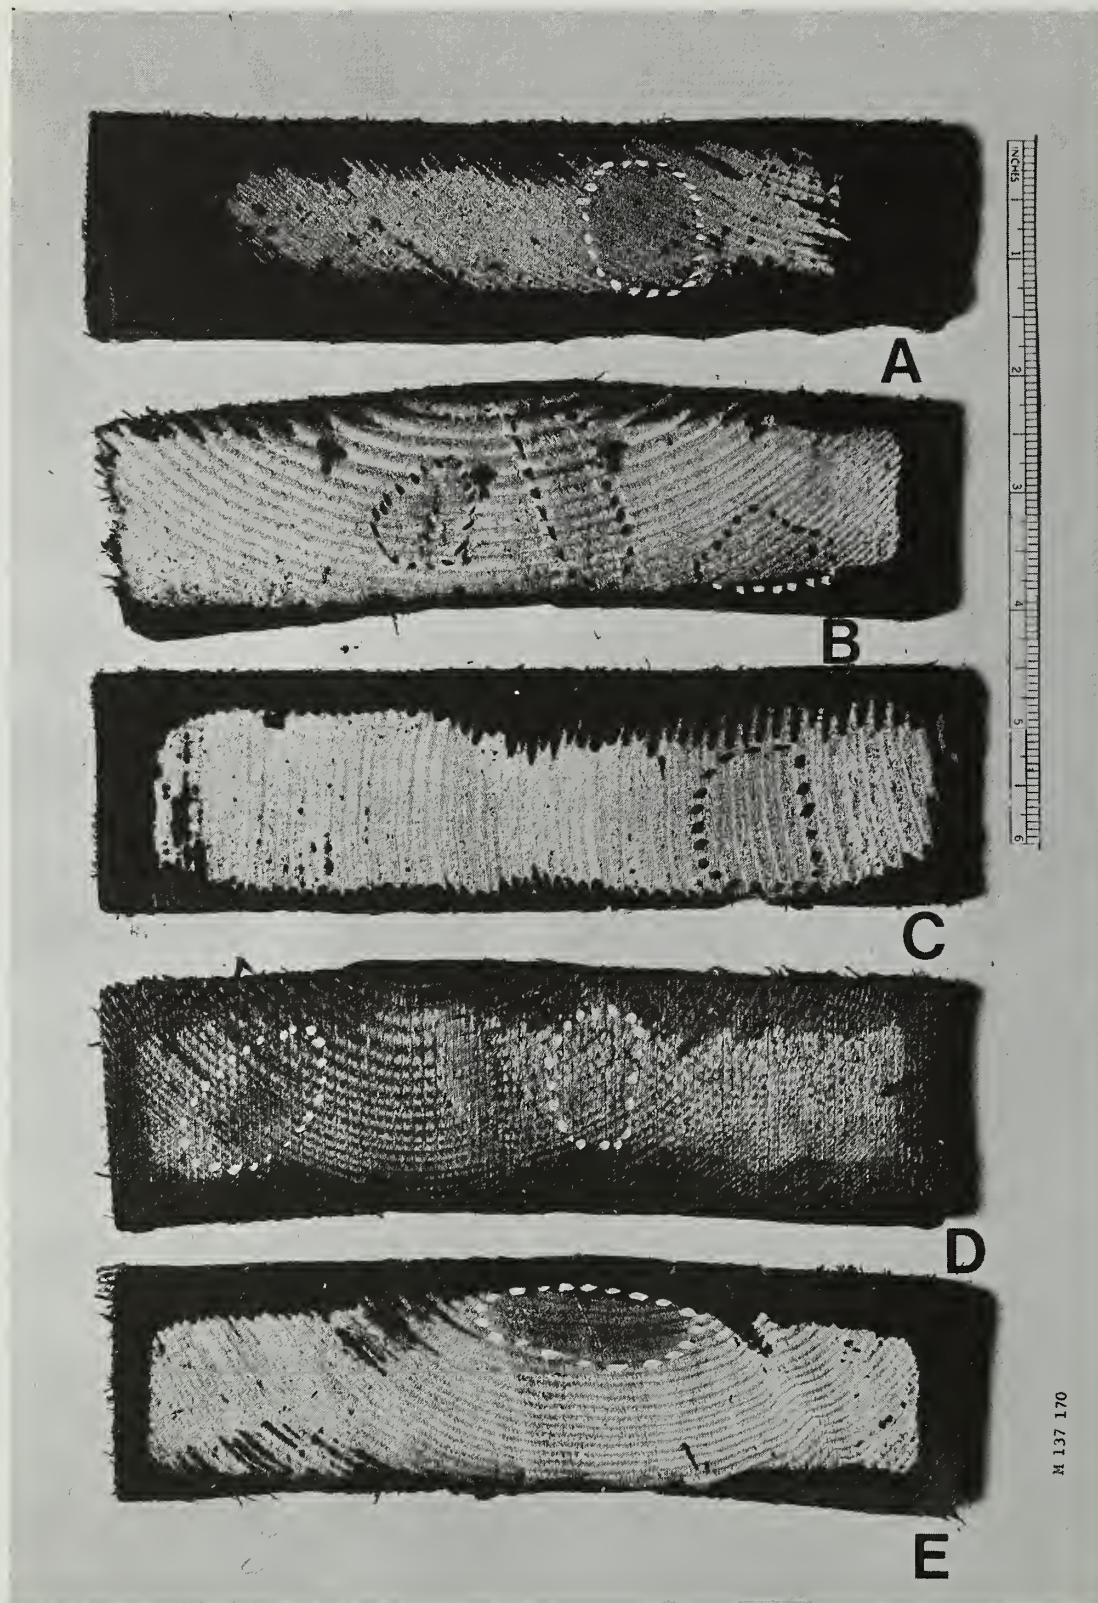
Figure 11.--All five decking samples show some incipient decay and some degree of iron stain. Both shrinkage and the resulting warp are evident by comparing the size and shape of the near normal shaped sample C, with the other four samples shown. From such an appraisal one can easily appreciate the nonuniform character of older nailed-laminated deck surfaces and spacing and the tendency of such decks to be severely loosened by repeated maximum loading after such shrinkage has occurred. B has a small area of typical or advanced decay. (M 137 170)
